# Manhole Inspection Summary

# Manhole # S23M1\_010MH

Insp Date: **1/21/09 11:49 AM**

**Location** Address: **2727 Norland Ave**

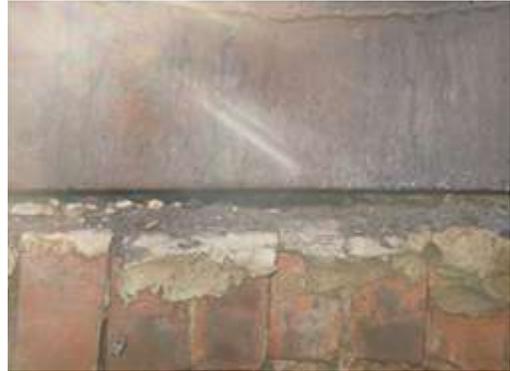
Defect 8

gap at the chimney/frame

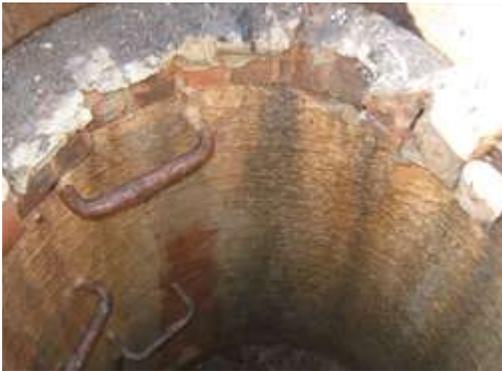
Defect 7

signs of infiltration in chimney and corbel and corroded rungs, frame offset

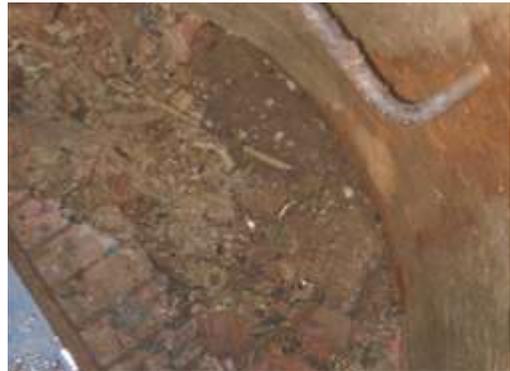
Defect 5

debris on becnh

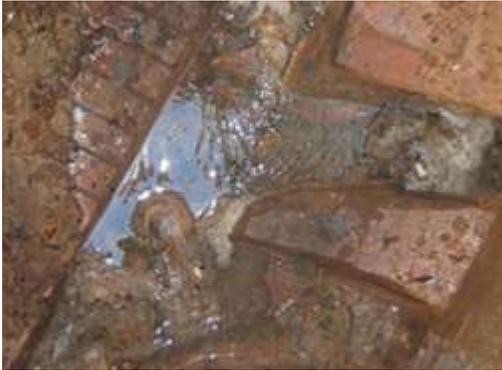
Defect 3

heavy debris in channels

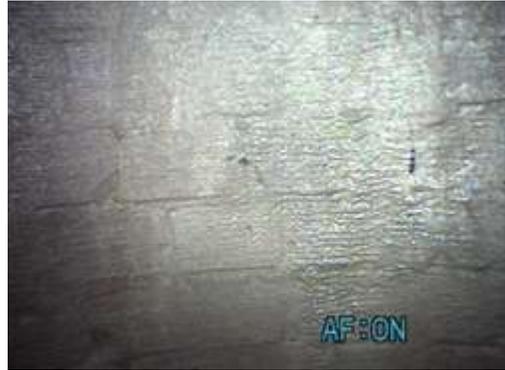
Defect 2

infiltration barrel wall

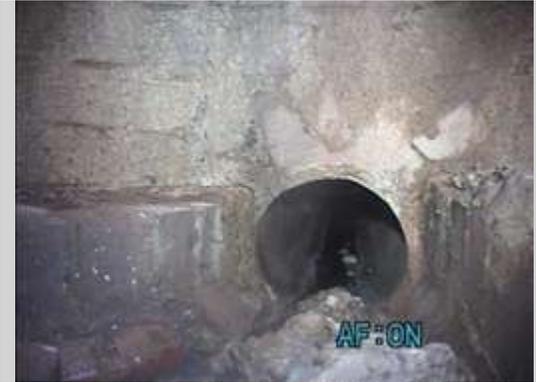
12 O'Clock Outflow

Pipe Height: **8.4** (in.) Rod and Bar (Angled)  
Pipe Material: **Clay**  Pipe Lined  
Invert Depth: **8.04** (ft.) Flow Characteristics: **Slow**  
Deposits:  None  Mud  Sludge  **Debris**  Grease  
Silt Depth: **3** (in.) Deposits Extent: **Medium**  
Infiltration: **None** Pipe Seal Cond: **Sound**

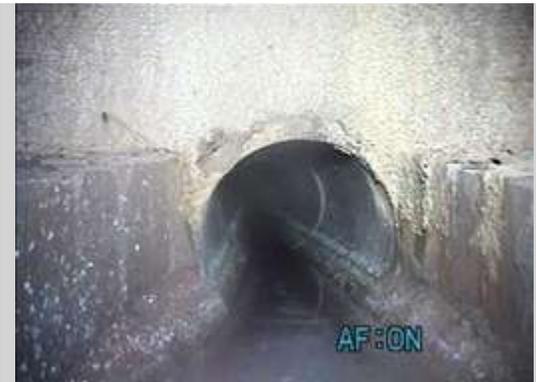
6 O'Clock Inflow

Pipe Height: **8.4** (in.) Rod and Bar (Angled)  
Pipe Material: **Clay**  Pipe Lined  
Invert Depth: **7.86** (ft.) Flow Characteristics: **Slow**  
Deposits:  None  Mud  Sludge  **Debris**  Grease  
Silt Depth: **0** (in.) Deposits Extent:  
Infiltration: **None** Pipe Seal Cond: **Sound**

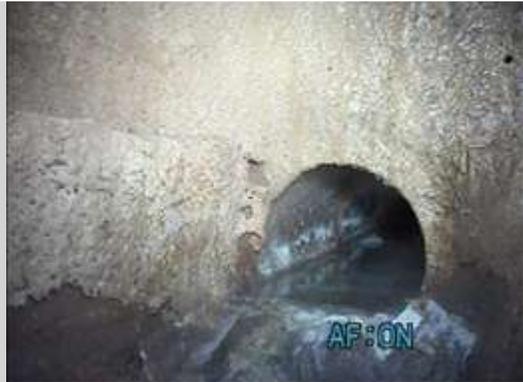
8 O'Clock Inflow

Pipe Height: **6** (in.) Rod and Bar (Angled)  
Pipe Material: **Clay**  Pipe Lined  
Invert Depth: **7.75** (ft.) Flow Characteristics: **Slow**  
Deposits:  None  Mud  Sludge  **Debris**  Grease  
Silt Depth: **3** (in.) Deposits Extent: **Medium**  
Infiltration: **None** Pipe Seal Cond: **Sound**

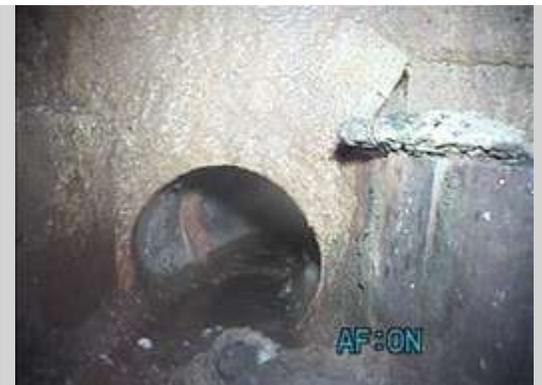
9 O'Clock Inflow

Pipe Height: **6** (in.) Rod and Bar (Angled)  
Pipe Material: **Clay**  Pipe Lined  
Invert Depth: **7.80** (ft.) Flow Characteristics: **Slow**  
Deposits:  None  Mud  Sludge  **Debris**  Grease  
Silt Depth: **0.5** (in.) Deposits Extent: **Light**  
Infiltration: **None** Pipe Seal Cond: **Sound**
